**Flood Control Project Maintenance
Levee Inspections**

Fall 2019 Levee Maintenance Deficiency Summary Report

San Joaquin River Basin

Madera County FCWCA

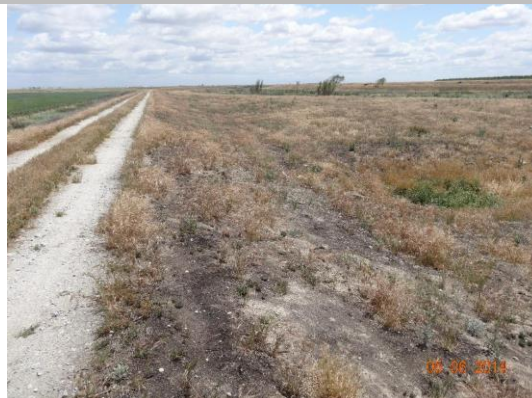
Photo 1 of 3 : UCIP_FA_2019_52833_64567.jpg

Comment Code						
Inspector Comment						
DS_ID:21520 FS_ID:52833 EP_NO: N/A Repair Type: Non-Urgent Crossing Status: Found UCIP Comments: 05/06/2014 Need to contact owner. Dense vegetation limits the inspector's visibility to identify signs of pipe failure (leaks) along the landward slope. Recommend removing vegetation along pipe alignment to conduct proper inspection of structure. (DWR UCIP - O. Magana) FIELD_STRUCT_DESC: 36-inch corrugated metal gravity drainage pipe through the levee, 10.8 feet below the crown. Headwall and wing wall on each end. Flap gate on the waterside (WS) end. [Additional Reference(s): DWR Levee Log, 2005]. FS Date: 5/6/2014

View of waterward side.

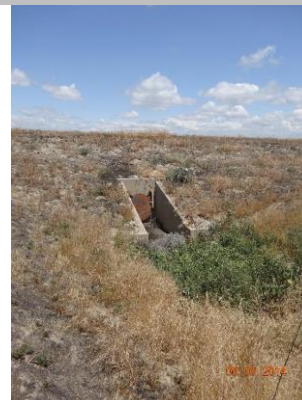
Photo 2 of 3 : UCIP_FA_2019_52833_64566.jpg

View of flap gate and concrete headwall located on waterward side.

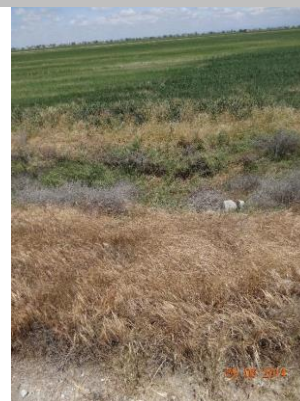
Photo 3 of 3 : UCIP_FA_2019_52833_64565.jpg

Comment Code						
Inspector Comment						
DS_ID:21520 FS_ID:52833 EP_NO: N/A Repair Type: Non-Urgent Crossing Status: Found UCIP Comments: 05/06/2014 Need to contact owner. Dense vegetation limits the inspector's visibility to identify signs of pipe failure (leaks) along the landward slope. Recommend removing vegetation along pipe alignment to conduct proper inspection of structure. (DWR UCIP - O. Magana) FIELD_STRUCT_DESC: 36-inch corrugated metal gravity drainage pipe through the levee, 10.8 feet below the crown. Headwall and wing wall on each end. Flap gate on the waterside (WS) end. [Additional Reference(s): DWR Levee Log, 2005]. FS Date: 5/6/2014

View of landward side.

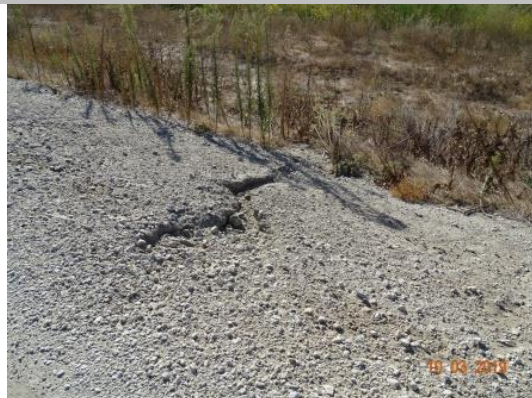
Photo 1 of 2 : FA_2019_NA0011_146_38_20191009_00040.jpg

LM Start	5.67	Rating **	M	Issue No.	38
LM End	5.67	Issue Type +	Ma	Location *	WS
Category	Earthen Levee			GPS Latitude/Longitude	
				Start	End
Item	Erosion / Bank Caving			36.968204°	36.968204°
				-120.271707°	-120.271707°
DWR ID	DWR_NA0011_05_f_2018_38				
Comment Code					
E2 : Schedule repair of erosion site prior to the next inspection.					
Inspector Comment

Erosion on waterside slope. (Fall 2019)

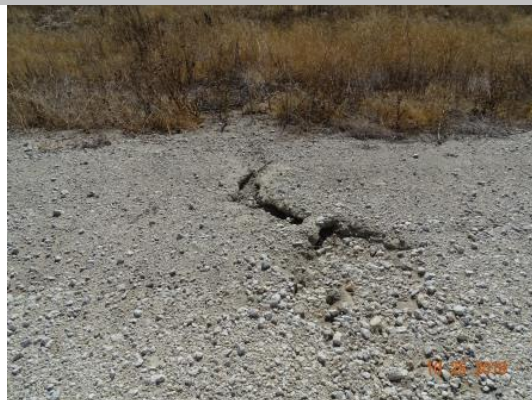
Photo 2 of 2 : FA_2019_NA0011_146_38_20190912_00018.jpg

Finger erosion on waterside slope. (Fall 2018)

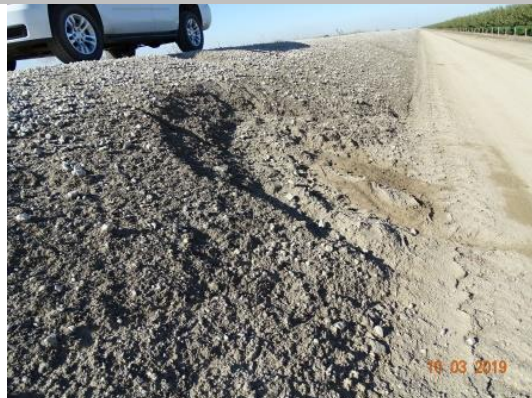
Photo 2 of 2 : FA_2019_NA0011_146_17_20191009_00042.jpg

LM Start	5.90	Rating **	M	Issue No.	17 (cont)	
LM End	5.90	Issue Type +	Ma	Location *	LS	
Category	Earthen Levee			GPS Latitude/Longitude		
				Start		End
Item	Erosion / Bank Caving			36.968205 °		36.968205 °
				-120.267562 °		-120.267562 °
DWR ID	DWR_NA0011_05_f_2019_17					
Comment Code						
E2 : Schedule repair of erosion site prior to the next inspection.						
Inspector Comment

View of erosion in landside slope. (Fall 2019)

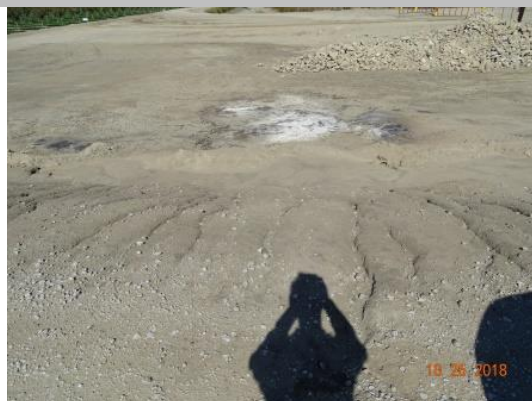
Photo 1 of 1 : FA_2019_NA0011_146_37_20190912_00017.jpg

LM Start	6.52	Rating **	A/W	Issue No.	37
LM End	6.52	Issue Type +	Ma	Location *	LS
Category	Earthen Levee			GPS Latitude/Longitude	
				Start	End
Item	Erosion / Bank Caving			36.968575 °	36.968575 °
				-120.256450 °	-120.256450 °
DWR ID	DWR_NA0011_05_f_2018_37				
Comment Code					
E1 : Note and monitor erosion site.					
Inspector Comment

Rill erosion on landside slope. (Fall 2018)

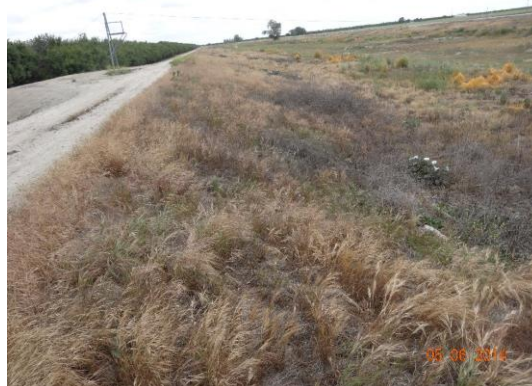
Photo 1 of 3 : UCIP_FA_2019_52859_69715.jpg

Comment Code						
Inspector Comment						
DS_ID:21527						
FS_ID:52859						
EP_NO: N/A						
Repair Type: Non-Urgent						
Crossing Status: Found						
UCIP Comments: 05/06/2014 Need to contact owner. Dense vegetation limits the inspector's visibility to identify signs of pipe failure (leaks) along the waterward slope. Recommend removing vegetation along pipe alignment to conduct proper inspection of structure and appurtenances. Slide gate buried on landward side. Recommend clearing sediment deposit on landward side. (DWR UCIP - O. Magana)						
FIELD_STRUCT_DESC: 30-inch corrugated metal gravity drainage pipe through the levee, 9.4 feet below the crown. Headwall and wing wall on each end. Flap gate on the waterside (WS) end. [Additional Reference(s): DWR Levee Log, 2005].						
FS Date: 5/6/2014

View of waterward side.

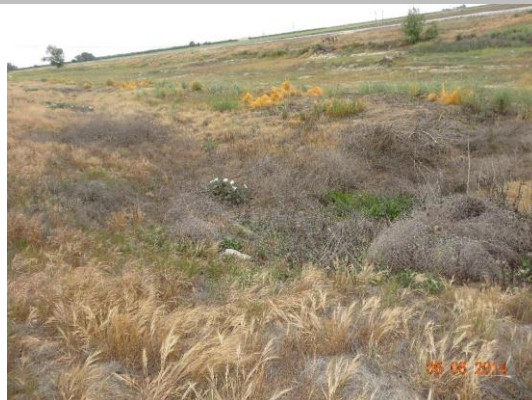
Photo 2 of 3 : UCIP_FA_2019_52859_69714.jpg

Concrete headwall covered by dense vegetation.

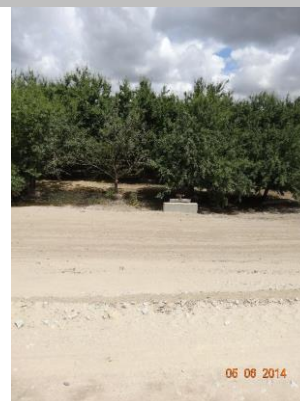
Photo 3 of 3 : UCIP_FA_2019_52859_69713.jpg

Comment Code						
Inspector Comment						
DS_ID:21527 FS_ID:52859 EP_NO: N/A Repair Type: Non-Urgent Crossing Status: Found UCIP Comments: 05/06/2014 Need to contact owner. Dense vegetation limits the inspector's visibility to identify signs of pipe failure (leaks) along the waterward slope. Recommend removing vegetation along pipe alignment to conduct proper inspection of structure and appurtenances. Slide gate buried on landward side. Recommend clearing sediment deposit on landward side. (DWR UCIP - O. Magana) FIELD_STRUCT_DESC: 30-inch corrugated metal gravity drainage pipe through the levee, 9.4 feet below the crown. Headwall and wing wall on each end. Flap gate on the waterside (WS) end. [Additional Reference(s): DWR Levee Log, 2005]. FS Date: 5/6/2014

View of landward side.

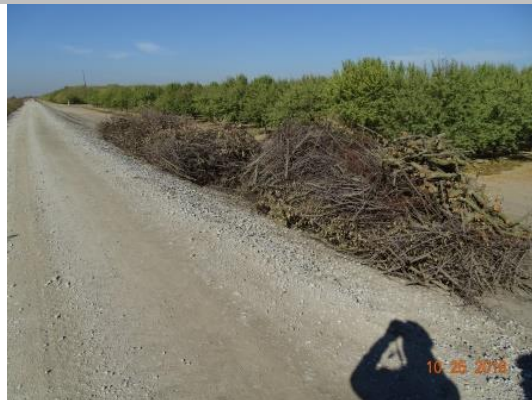
Photo 2 of 2 : FA_2019_NA0011_146_30_20190912_00015.jpg

LM Start	7.63	Rating **	M	Issue No.	30 (cont)	
LM End	7.63	Issue Type +	En	Location *	LS	
Category	Earthen Levee			GPS Latitude/Longitude		
				Start		End
Item	Encroachments			36.969550 °		36.969550 °
				-120.236670 °		-120.236670 °
DWR ID	DWR_NA0011_05_f_2018_30					
Comment Code						
PR : Prunings						
Inspector Comment						
Prunings left on landside slope.

Pruning piles on landside slope. (Fall 2018)

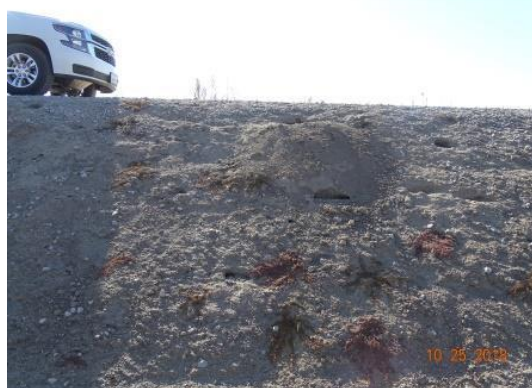
Photo 1 of 1 : FA_2019_NA0011_146_12_20190912_00004.jpg

LM Start	7.99	Rating **	U	Issue No.	12
LM End	8.01	Issue Type +	Ma	Location *	LS
Category	Earthen Levee			GPS Latitude/Longitude	
				Start	End
Item	Animal Control			36.972121 °	36.972186 °
				-120.230994 °	-120.230772 °
DWR ID	DWR_NA0011_05_f_2018_12				
Comment Code					
A3 : No rodents visible, but rodent burrows visible; need to backfill and compact or grout burrows.					
Inspector Comment					
Large rodent burrow observed in this section.

Rodent activity on landside slope. (Fall 2018)

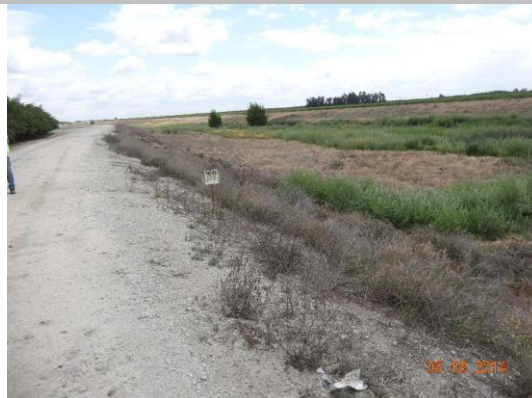
Photo 1 of 3 : UCIP_FA_2019_52863_69719.jpg

Comment Code						
Inspector Comment						
DS_ID:21528 FS_ID:52863 EP_NO: N/A Repair Type: Non-Urgent Crossing Status: Found UCIP Comments: 05/06/2014 Need to contact owner. Dense vegetation limits the inspector's visibility to identify signs of pipe failure (leaks) along the waterward slope. Recommend removing vegetation along pipe alignment to conduct proper inspection of structure and appurtenances. (DWR UCIP - O. Magana) FIELD_STRUCT_DESC: 30-inch corrugated metal gravity drainage pipe through the levee, 8.3 feet below the crown. Headwall and wing wall on each end. Flap gate on the waterside (WS) end. [Additional Reference(s): DWR Levee Log, 2005]. FS Date: 5/6/2014

View of waterward side.

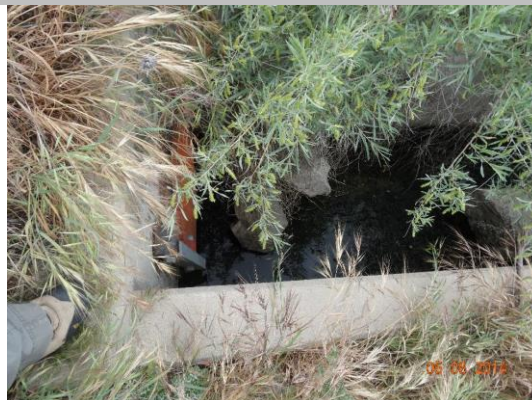
Photo 2 of 3 : UCIP_FA_2019_52863_69721.jpg

Concrete headwall visible on waterward side and covered by dense vegetation.

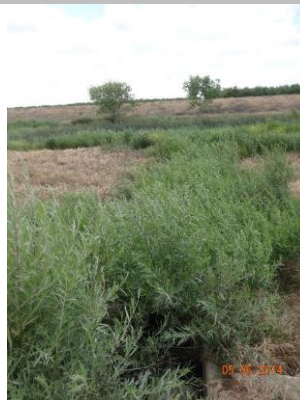
Photo 3 of 3 : UCIP_FA_2019_52863_69720.jpg

Comment Code						
Inspector Comment						
DS_ID:21528 FS_ID:52863 EP_NO: N/A Repair Type: Non-Urgent Crossing Status: Found UCIP Comments: 05/06/2014 Need to contact owner. Dense vegetation limits the inspector's visibility to identify signs of pipe failure (leaks) along the waterward slope. Recommend removing vegetation along pipe alignment to conduct proper inspection of structure and appurtenances. (DWR UCIP - O. Magana) FIELD_STRUCT_DESC: 30-inch corrugated metal gravity drainage pipe through the levee, 8.3 feet below the crown. Headwall and wing wall on each end. Flap gate on the waterside (WS) end. [Additional Reference(s): DWR Levee Log, 2005]. FS Date: 5/6/2014

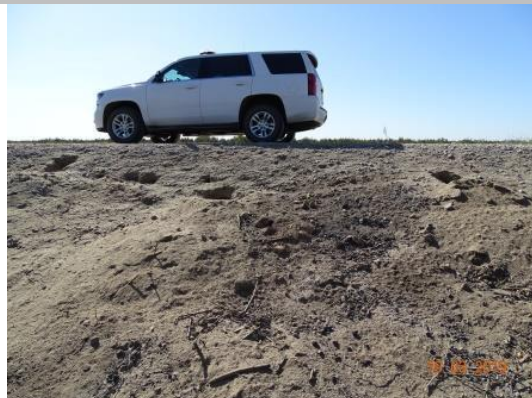
Photo 1 of 2 : FA_2019_NA0011_146_51_20191009_00046.jpg

LM Start	8.40	Rating **	U	Issue No.	51
LM End	8.40	Issue Type +	Ma	Location *	LS
Category	Earthen Levee			GPS Latitude/Longitude	
				Start	End
Item	Animal Control			36.972953 °	36.972953 °
				-120.223839 °	-120.223839 °
DWR ID	DWR_NA0011_05_s_2019_51				
Comment Code					
A3 : No rodents visible, but rodent burrows visible; need to backfill and compact or grout burrows.					
Inspector Comment

Several rodent holes observed at this location. (Fall 2019)

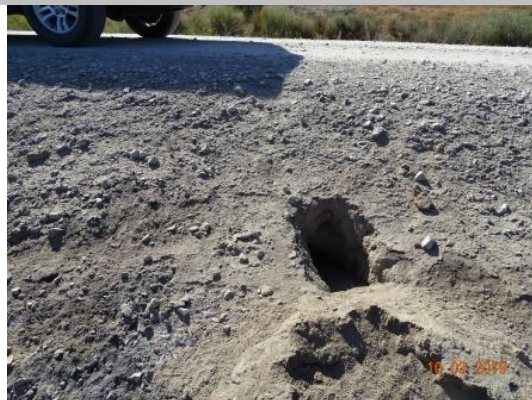
Photo 2 of 2 : FA_2019_NA0011_146_51_20191009_00047.jpg

View of rodent burrow in landside slope. (Fall 2019)

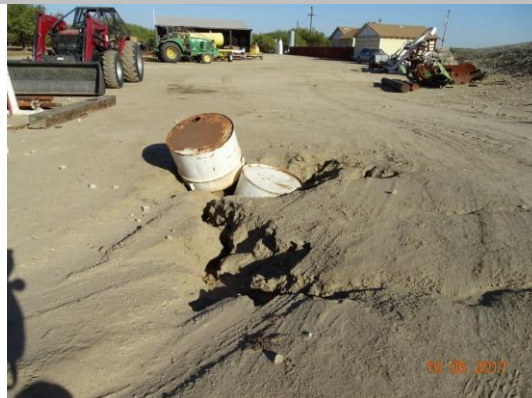
Photo 2 of 2 : FA_2019_NA0011_146_25_20190912_00011.jpg

LM Start	8.53	Rating **	M	Issue No.	25 (cont)	
LM End	8.53	Issue Type +	En	Location *	LS	
Category	Earthen Levee			GPS Latitude/Longitude		
				Start		End
Item	Encroachments			36.972643 °		36.972643 °
				-120.221488 °		-120.221488 °
DWR ID	DWR_NA0011_05_f_2017_25					
Comment Code						
PI : Pipe						
Inspector Comment						
Possible sinkhole 10 feet from landside levee toe. 6 ft long by 1-2 ft wide by 5.5 ft deep. 55gal drum halves were placed in hole for safety. Met with Rick Cosyns (MID 559-232-0227) on site. Speculated that it was likely an underground pipe with collapsed backfill.

Possible sinkhole 10 feet from landside levee toe. 6 ft long by 1-2 ft wide by 5.5 ft deep. White 55gal drum halves were placed in hole for safety.

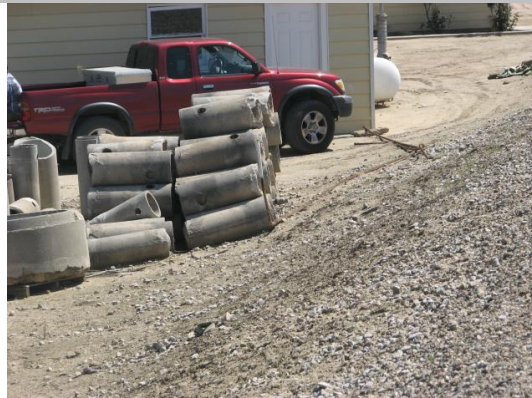
Photo 1 of 1 : FA_2019_NA0011_146_26_20190912_00012.jpg

LM Start	8.53	Rating **	M	Issue No.	26
LM End	8.53	Issue Type +	En	Location *	LS
Category	Earthen Levee			GPS Latitude/Longitude	
				Start	End
Item	Encroachments			36.972616 °	36.972606 °
				-120.221415 °	-120.221389 °
DWR ID	DWR_NA0011_05_f_2017_26				
Comment Code					
EQ : Equipment					
Inspector Comment					
Concrete pipes at landward toe.

Looking upstream at concrete pipes stored at landward toe. (Spring 2018)

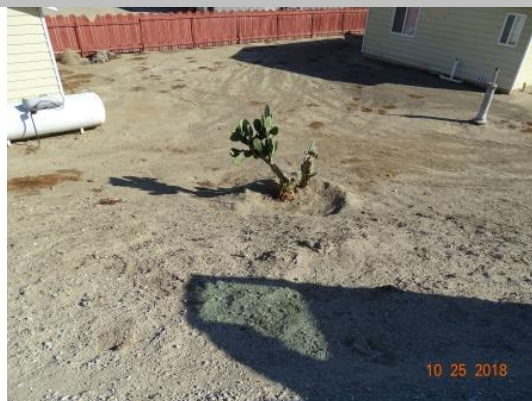
Photo 1 of 1 : FA_2019_NA0011_146_11_20190912_00003.jpg

LM Start	8.56	Rating **	M	Issue No.	11
LM End	8.56	Issue Type +	En	Location *	LS
Category	Earthen Levee			GPS Latitude/Longitude	
				Start	End
Item	Vegetation			36.972384 °	36.972384 °
				-120.220907 °	-120.220907 °
DWR ID	DWR_NA0011_05_f_2018_11				
Comment Code					
V6 : Landscaping					
Inspector Comment					
Cactus planted on landside toe.

Cactus on landside toe. (Fall 2018)

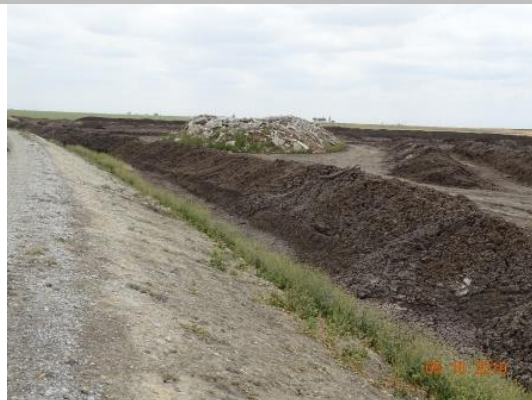
Photo 1 of 1 : FA_2019_NA0011_147_85_20190912_00028.jpg

LM Start	0.99	Rating **	U	Issue No.	85
LM End	1.07	Issue Type +	En	Location *	LS
Category	Earthen Levee			GPS Latitude/Longitude	
				Start	End
Item	Encroachments			36.968930 °	36.967985 °
				-120.354292 °	-120.353510 °
DWR ID	DWR_NA0011_06_s_2019_85				
Comment Code					
MA : Material					
Inspector Comment					
Soil material piled up on levee toe should be pushed back 10 feet from slope.

View of soil encroachment piled along levee toe. (Spring 2019)

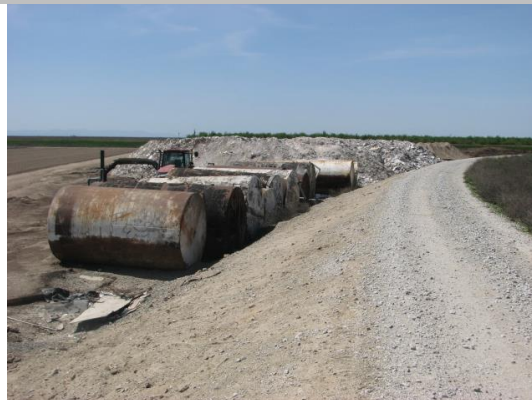
Photo 1 of 2 : FA_2019_NA0011_147_1_20190912_00001.jpg

LM Start	1.08	Rating **	U	Issue No.	1
LM End	1.14	Issue Type +	En	Location *	LS
Category	Earthen Levee			GPS Latitude/Longitude	
				Start	End
Item	Encroachments			36.967781°	36.967395°
				-120.353321°	-120.352362°
DWR ID	DWR_NA0011_06_s_2012_1				
Comment Code					
DE : Debris					
Inspector Comment					
Large piles of broken up recycled sheet rock placed within 10-foot of the levee easement.

Looking upstream at tanks and sheet rock piles at landward toe. (Spring 2018)

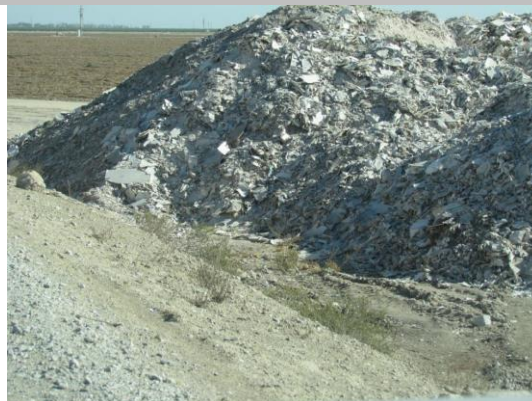
Photo 2 of 2 : FA_2019_NA0011_147_1_20190912_00002.jpg

Recycle sheet rock piles within the landside easement.

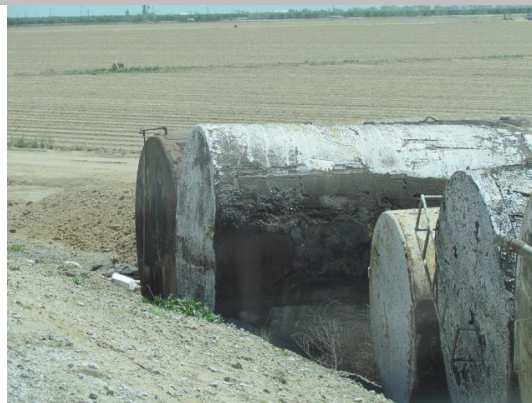
Photo 1 of 1 : FA_2019_NA0011_147_39_20190912_00015.jpg

LM Start	1.14	Rating **	U	Issue No.	39
LM End	1.17	Issue Type +	En	Location *	LS
Category	Earthen Levee			GPS Latitude/Longitude	
				Start	End
Item	Encroachments			36.967387°	36.967270°
				-120.352340°	-120.351902°
DWR ID	DWR_NA0011_06_s_2014_39				
Comment Code					
TA : Tank					
Inspector Comment					
Metal storage tanks are within the easement of the landward toe. Move them away from the easement.

Fresno River landside levee mile 1.16.

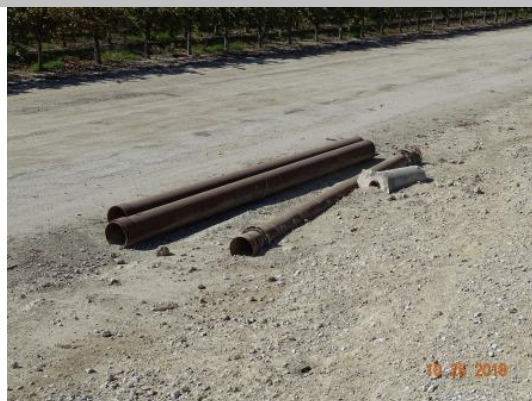
Photo 1 of 1 : FA_2019_NA0011_147_24_20190912_00007.jpg

LM Start	3.39	Rating **	M	Issue No.	24
LM End	3.39	Issue Type +	En	Location *	LS
Category	Earthen Levee			GPS Latitude/Longitude	
				Start	End
Item	Encroachments			36.967378 °	36.967378 °
				-120.311737 °	-120.311737 °
DWR ID	DWR_NA0011_06_f_2017_24				
Comment Code					
EQ : Equipment					
Inspector Comment					
Remove large pipe sections from toe of levee.

Pipe segments left at levee toe. (Fall 2018)

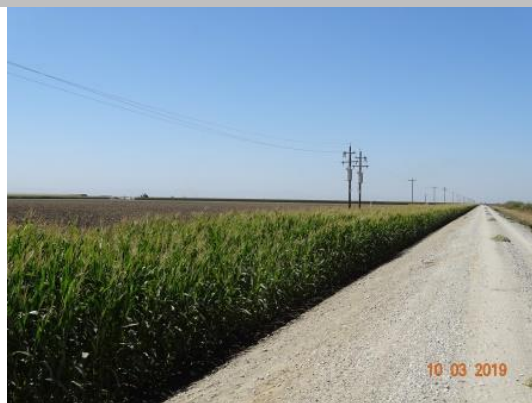
Photo 1 of 2 : FA_2019_NA0011_147_77_20191009_00050.jpg

LM Start	3.99	Rating **	U	Issue No.	77
LM End	5.48	Issue Type +	En	Location *	LS
Category	Earthen Levee			GPS Latitude/Longitude	
				Start	End
Item	Encroachments			36.967439 °	36.967487 °
				-120.300974 °	-120.273999 °
DWR ID	DWR_NA0011_06_s_2019_77				
Comment Code					
CR : Crops					
Inspector Comment					
Landowner has planted corn along the landside toe.

Corn planted on the landside toe. (Fall 2019)

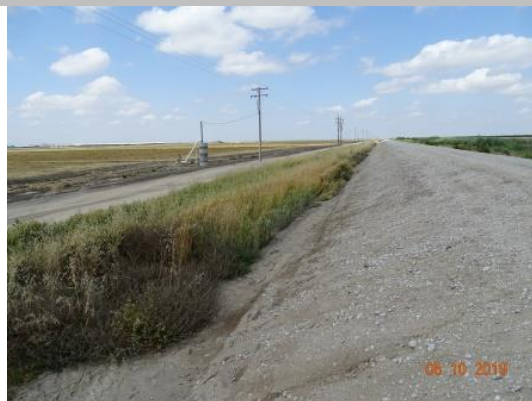
Photo 2 of 2 : FA_2019_NA0011_147_77_20190912_00026.jpg

Crops planted on the landside toe. (Spring 2019)

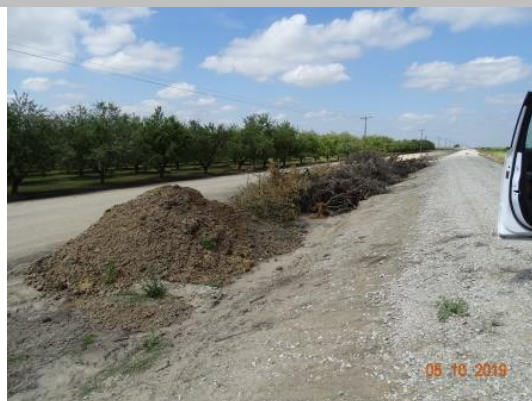
Photo 1 of 1 : FA_2019_NA0011_147_38_20190912_00014.jpg

LM Start	6.09	Rating **	U	Issue No.	38
LM End	6.13	Issue Type +	En	Location *	LS
Category	Earthen Levee			GPS Latitude/Longitude	
				Start	End
Item	Encroachments			36.967482 °	36.967511 °
				-120.262984 °	-120.262342 °
DWR ID	DWR_NA0011_06_f_2017_38				
Comment Code					
TR : Tree or limb					
Inspector Comment					
Remove downed trees and associated debris pile from levee toe.

View of debris pile and pruning piles along landside toe. (Spring 2019)

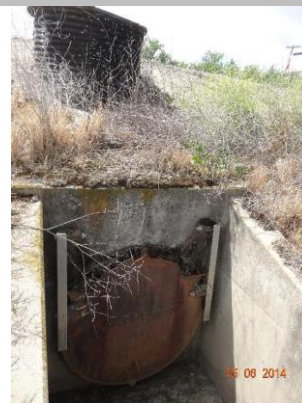
Photo 2 of 3 : UCIP_FA_2019_52854_64573.jpg

Flap gate, concrete headwall, and standpipe on waterward side.

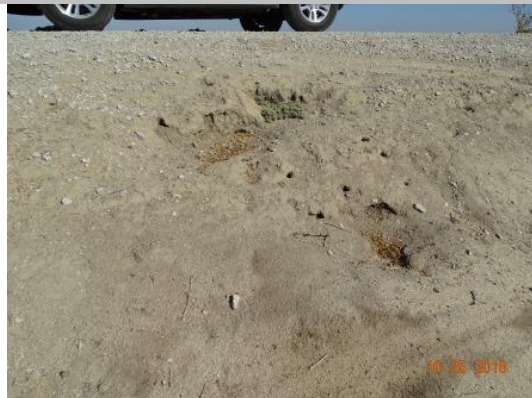
Photo 1 of 1 : FA_2019_NA0011_147_58_20190912_00024.jpg

Minor erosion on landside slope. (Fall 2018)

LM Start	6.29	Rating **	M	Issue No.	58
LM End	6.29	Issue Type +	Ma	Location *	LS
Category	Earthen Levee			GPS Latitude/Longitude	
				Start	End
Item	Erosion / Bank Caving			36.967750 °	36.967750 °
				-120.259385 °	-120.259385 °
DWR ID	DWR_NA0011_06_f_2018_58				
Comment Code					
E2 : Schedule repair of erosion site prior to the next inspection.					
Inspector Comment

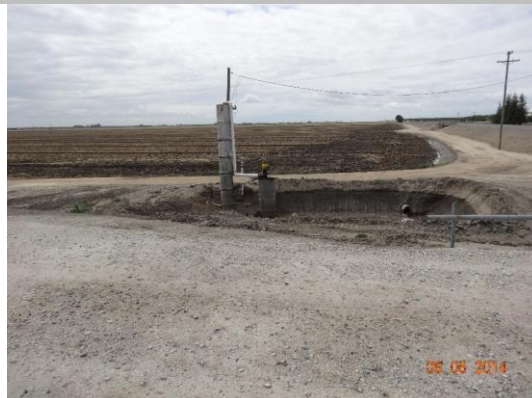
Photo 2 of 3 : UCIP_FA_2019_52855_69724.jpg

Comment Code						
Inspector Comment						
DS_ID:21532						
FS_ID:52855						
EP_NO: N/A						
Repair Type: Non-Urgent						
Crossing Status: Found						
UCIP Comments: 7/14/2016 Same as previous inspection. Need to coordinate with owner. Need permit number authorizing work. (DWR UCIP - omagana)5/06/2014 Need to contact owner. Crossing on landward side appears to be modified--no headwall found on landward end. (DWR UCIP - omagana)						
FIELD_STRUCT_DESC: 30-inch corrugated metal pipe (CMP) of an unknown purpose through the levee, 12 feet below the crown. Slide gate in a 5-foot CMP riser on the waterside (WS) shoulder. Headwall and wing wall on the WS end. Concrete headwall on the landside (LS) end. [Additional Reference(s): DWR Levee Log, 2005].						
FS Date: 7/14/2016

View of LS.

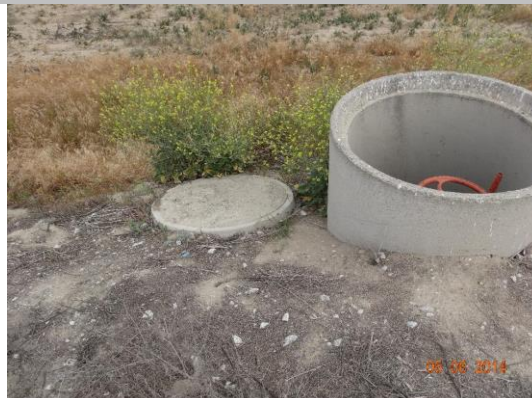
Photo 2 of 3 : UCIP_FA_2019_52860_64588.jpg

Comment Code						
Inspector Comment						
DS_ID:21587 FS_ID:52860 EP_NO: 13837 Repair Type: Non-Urgent Crossing Status: Found UCIP Comments: 05/06/2014 Need to contact owner. Dense vegetation limits the inspector's visibility to identify signs of pipe failure (leaks) along the waterward slope. Recommend removing vegetation along pipe alignment to conduct proper inspection of structure and appurtenances. (DWR UCIP - O. Magana) FIELD_STRUCT_DESC: 12-inch reinforced concrete gravity irrigation pipe through the levee, 7.5 feet below the floodplain. The pipe extends to a 27-inch concrete standpipe in the overflow area and through the levee section to a 30-inch standpipe on the landside (LS). Positive closure device with walkway on the waterside (WS). (Plans to install a 20-inch concrete pipe through the levee for irrigation authorized under Permit No. 13837, 1984 - Averill Ranch). FS Date: 5/6/2014

View of concrete standpipe and lid found on waterward shoulder.

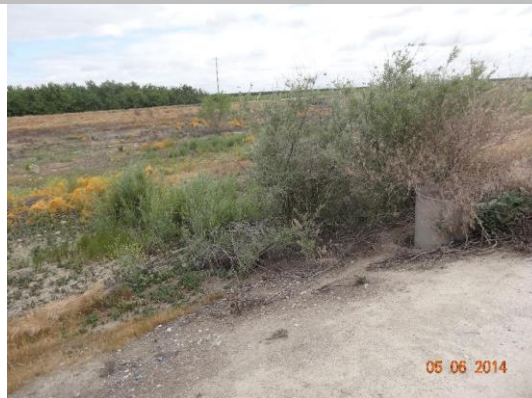
Photo 1 of 3 : UCIP_FA_2019_52861_64590.jpg

Comment Code						
Inspector Comment						
DS_ID:21588 FS_ID:52861 EP_NO: 13856 Repair Type: Non-Urgent Crossing Status: Found UCIP Comments: 05/06/2014 Need to contact owner. Dense vegetation limits the inspector's visibility to identify signs of pipe failure (leaks) along the waterward slope. Recommend removing vegetation along pipe alignment to conduct proper inspection of structure and appurtenances. (DWR UCIP - O. Magana) FIELD_STRUCT_DESC: 12-inch reinforced concrete gravity irrigation pipe through the levee, approximately 4 feet below the crown. The pipe extends from a 24-inch standpipe in the overflow area and through the levee section to a 36-inch standpipe on the landside (LS). Positive closure device with a walkway on the waterside (WS). (Plans to install a 20-inch concrete gravity irrigation pipe through the levee authorized under Permit No. 13856, 1984 - Averill Ranch). FS Date: 5/6/2014

View of waterward side.

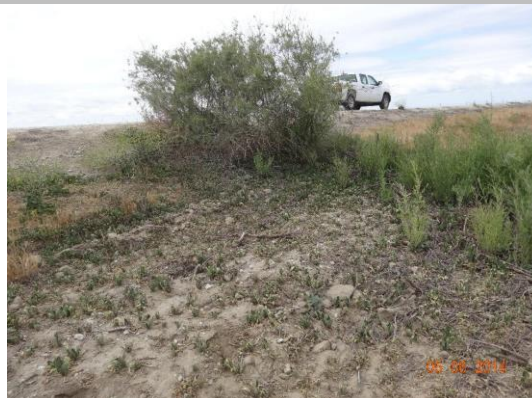
Photo 3 of 3 : UCIP_FA_2019_52861_64594.jpg

Comment Code						
Inspector Comment						
DS_ID:21588 FS_ID:52861 EP_NO: 13856 Repair Type: Non-Urgent Crossing Status: Found UCIP Comments: 05/06/2014 Need to contact owner. Dense vegetation limits the inspector's visibility to identify signs of pipe failure (leaks) along the waterward slope. Recommend removing vegetation along pipe alignment to conduct proper inspection of structure and appurtenances. (DWR UCIP - O. Magana) FIELD_STRUCT_DESC: 12-inch reinforced concrete gravity irrigation pipe through the levee, approximately 4 feet below the crown. The pipe extends from a 24-inch standpipe in the overflow area and through the levee section to a 36-inch standpipe on the landside (LS). Positive closure device with a walkway on the waterside (WS). (Plans to install a 20-inch concrete gravity irrigation pipe through the levee authorized under Permit No. 13856, 1984 - Averill Ranch). FS Date: 5/6/2014

View of waterward slope.

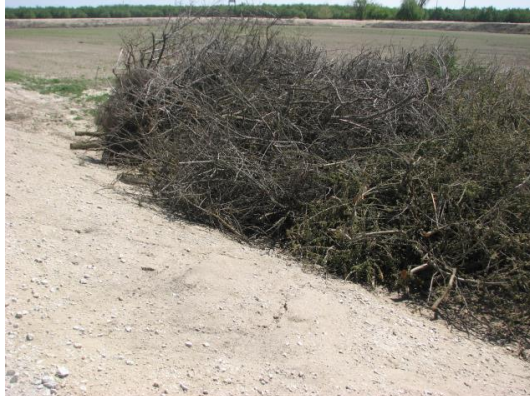
Photo 2 of 2 : FA_2019_NA0011_147_52_20190912_00021.jpg

LM Start	7.49	Rating **	U	Issue No.	52 (cont)	
LM End	7.49	Issue Type +	En	Location *	LS	
Category	Earthen Levee			GPS Latitude/Longitude		
				Start		End
Item	Encroachments			36.968886 °		36.968886 °
				-120.237967 °		-120.237967 °
DWR ID	DWR_NA0011_06_s_2018_52					
Comment Code						
PR : Prunings						
Inspector Comment						
Farmer is piling large tree limbs and branches at landward toe.

Looking downstream at prunings at landward toe. (Spring 2018)

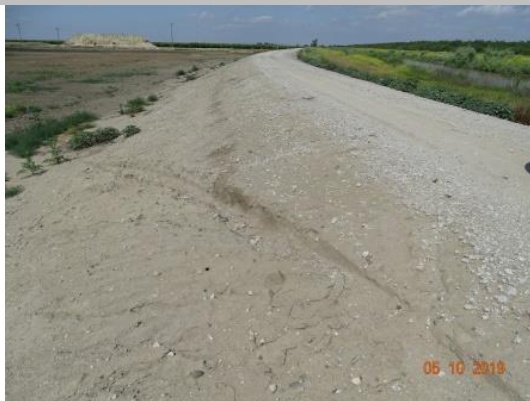
Photo 1 of 1 : FA_2019_NA0011_147_59_20190912_00025.jpg

View of vehicle tracks on landside slope. (Spring 2019)

LM Start	7.61	Rating **	M	Issue No.	59
LM End	7.61	Issue Type +	Ma	Location *	LS
Category	Earthen Levee			GPS Latitude/Longitude	
				Start	End
Item	Slope Stability			36.968965 °	36.968965 °
				-120.235734 °	-120.235734 °
DWR ID	DWR_NA0011_06_s_2019_59				
Comment Code					
S3 : Repair the levee slope damaged by vehicle traffic and prevent access where possible.					
Inspector Comment

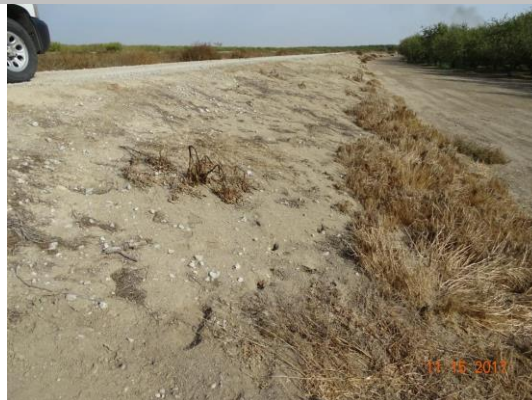
Photo 1 of 1 : FA_2019_NA0011_147_47_20190912_00016.jpg

LM Start	7.71	Rating **	M	Issue No.	47							
LM End	8.52	Issue Type +	Ma	Location *	LS							
Category	Earthen Levee		GPS Latitude/Longitude									
			Start	End								
Item	Animal Control		36.969600°	36.971509°								
			-120.234229°	-120.220438°								
DWR ID	DWR_NA0011_06_f_2017_47											
Comment Code												
A3 : No rodents visible, but rodent burrows visible; need to backfill and compact or grout burrows.												
Inspector Comment

Bait traps should be maintained and rodent holes should be backfilled.

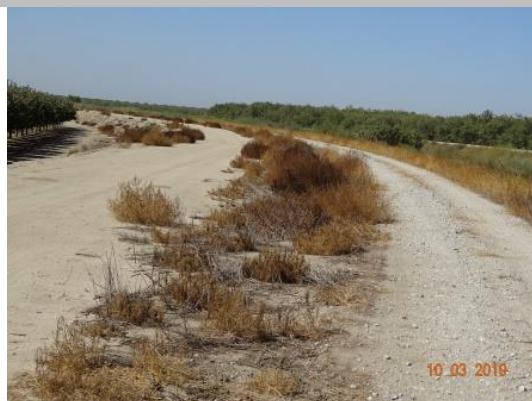
Photo 1 of 1 : FA_2019_NA0011_147_15_20191009_00053.jpg

Vegetation growing along levee crown. (Fall 2019)

LM Start	8.00	Rating **	M	Issue No.	15
LM End	8.40	Issue Type +	Ma	Location *	CR
Category	Earthen Levee			GPS Latitude/Longitude	
				Start	End
Item	Vegetation			36.971673 °	36.972195 °
				-120.229700 °	-120.222448 °
DWR ID	DWR_NA0011_06_f_2019_15				
Comment Code					
V9 : Keep the crown roadway free of vegetation.					
Inspector Comment

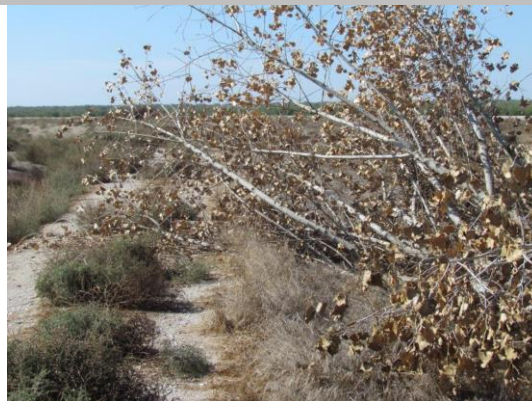
Photo 1 of 2 : FA_2019_NA0011_147_36_20190912_00011.jpg

LM Start	8.03	Rating **	M	Issue No.	36
LM End	8.03	Issue Type +	Ma	Location *	WS
Category	Earthen Levee			GPS Latitude/Longitude	
				Start	End
Item	Encroachments			36.971582 °	36.971582 °
				-120.229180 °	-120.229180 °
DWR ID	DWR_NA0011_06_f_2015_36				
Comment Code					
TR : Tree or limb					
Inspector Comment					
The dead tree has been removed from blocking the roadway but still needs to be removed from the levee section.

Dead tree pushed upon the waterside slope and blocking the crown.

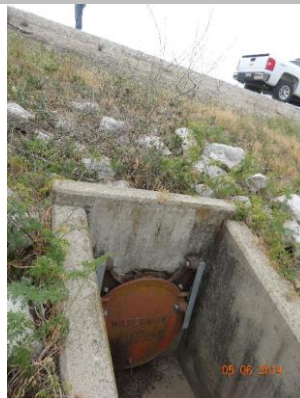
Photo 3 of 3 : UCIP_FA_2019_52864_64598.jpg

LM Start	8.53	Rating **	M	Issue No.	90 (cont)	
LM End	8.53	Issue Type +	En	Location *		
Category	Supplemental			GPS Latitude/Longitude		
				Start	End	
Item	DRAFT DWR UCIP Field Study			36.971462 °	36.971462 °	
				-120.220276 °	-120.220276 °	
DWR ID	21534					
Comment Code						
Inspector Comment						
DS_ID:21534 FS_ID:52864 EP_NO: N/A Repair Type: Non-Urgent Crossing Status: Found UCIP Comments: 05/06/2014 Need to contact owner. Rip rap has been added around concrete headwall on waterward side--need to determine details for rip rap around structure. (DWR UCIP - O. Magana) FIELD_STRUCT_DESC: 30-inch corrugated metal gravity drainage pipe through the levee, 11 feet below the crown. Headwall and wing wall on each end. Flap gate on the waterside (WS) end. [Additional Reference(s): DWR Levee Log, 2005]. FS Date: 5/6/2014

Flap gate visible on waterward side.

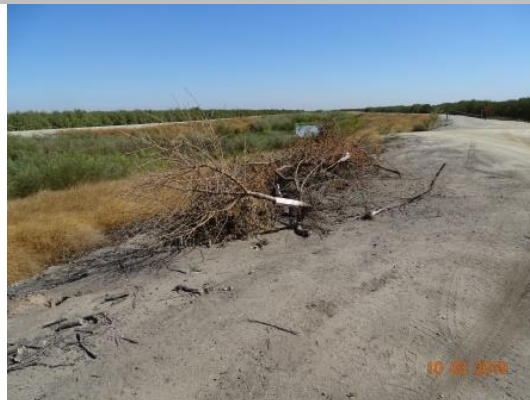
Photo 1 of 1 : FA_2019_NA0011_147_11_20191009_00054.jpg

Pruning pile left on waterside shoulder and levee crown. (Fall 2019)

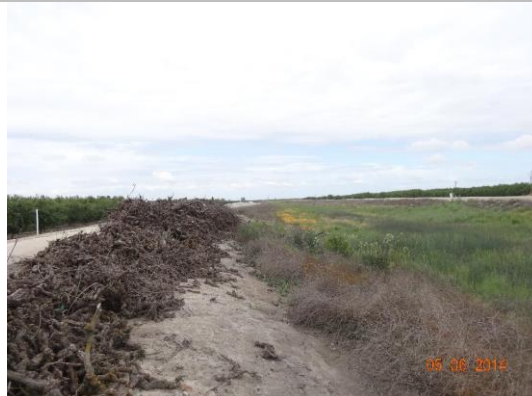
Photo 1 of 3 : UCIP_FA_2019_53156_64605.jpg

View of WS.

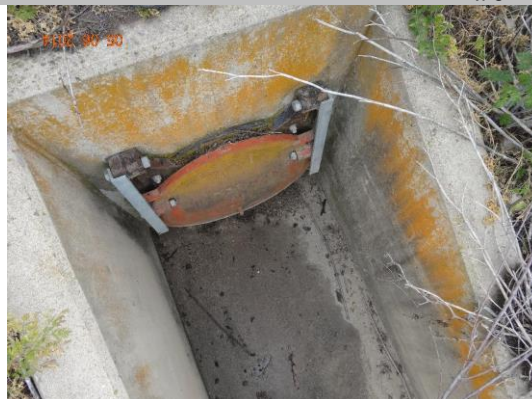
Photo 2 of 3 : UCIP_FA_2019_53156_64604.jpg

Flap gate visible on WS.
